August, 2017

Vol 2. No. 008

# GNPPO NEWSLETTER

## FUKUSHIMA NUCLEAR ACCIDENT

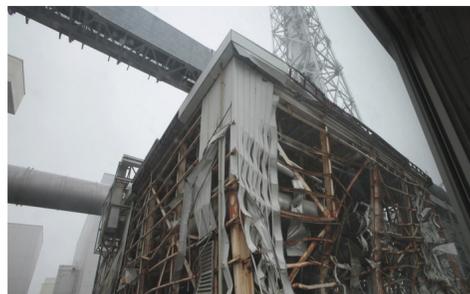
Corbis-RM-fukushima-disaster-damaged-building

The buildup of hydrogen generated during the accident, collected within the reactor buildings and caused explosions in the upper portions of the unit 1, 3 and 4 reactor buildings. The spent fuel pools in these buildings were exposed leading to releases of radioactive materials into the environment. It must however be stated that there was no damage to the spent fuel itself.

Fukushima Daiichi Units 1-3 were heavily damaged in the March 2011 disaster. Unit 4 suffered less severe damage, but its reactor building was destroyed by a hydrogen explosion caused by a shared ventilation line with Unit 3. Units 5 and 6 remain undamaged but the overall contamination of the area will make operation impracticable now. Despite immense technical challenges, clean up continues. Since March 2011, all six reactors at the Fukushima Daiichi site have been shut down.
